## Assessment Report for: JS Jenks Academy

<b>Inspection Date:</b> Friday, Dec 12, 2025	<b>Playground Name:</b> Philadelphia PA #3196	<b>Report Date:</b> 01/8/26
<b>Inspector:</b> Bill Meyers	<b>Date playground was built:</b> 1997	<b>Report submitted by:</b> Marc Leathers

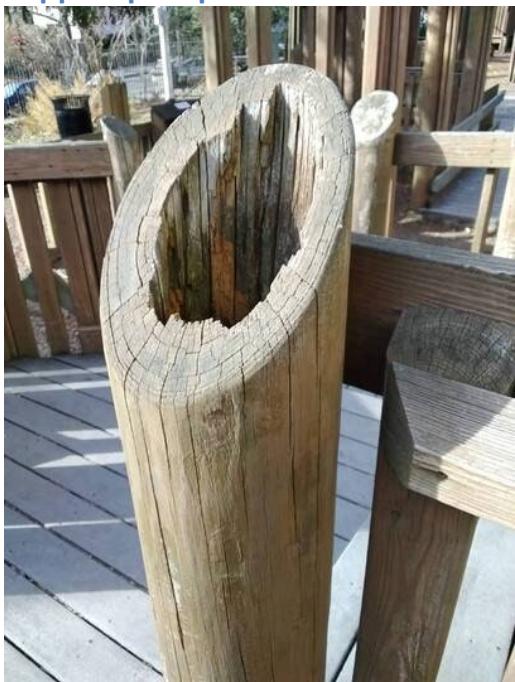
#### Support post picture #1

Grade C - The component has normal wear and tear.

In ground posts show normal wear with minor decay. Many posts have significant dry rot along tops.

Sand and seal weathered posts., Trim damaged top back to dense wood and seal., Repair / Replace damaged poles with similar materials.

In addition to minor recommendations, replace posts with new materials in areas to be reimagined during major renovation.

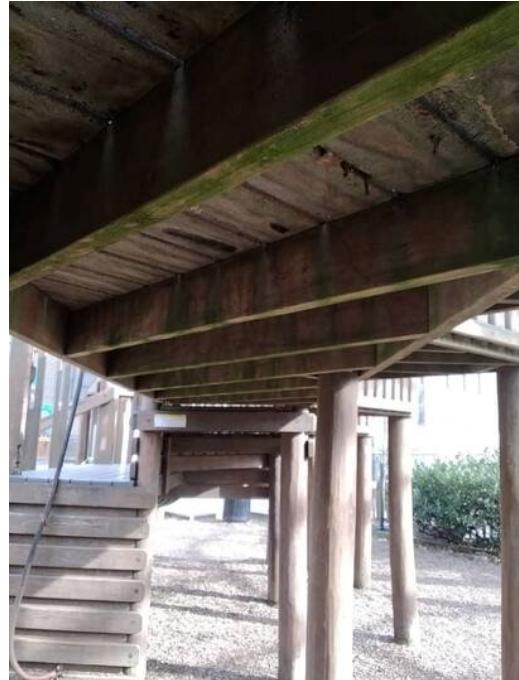
**Framing picture #2**

Grade C - The component has normal wear and tear.

Framing in main area is sound. Tot lot areas have significant settling and uneven surfaces. Tot tower has settled and is leaning.

Repair / Replace damaged framing with similar materials.

Consider replacing tot area structures.

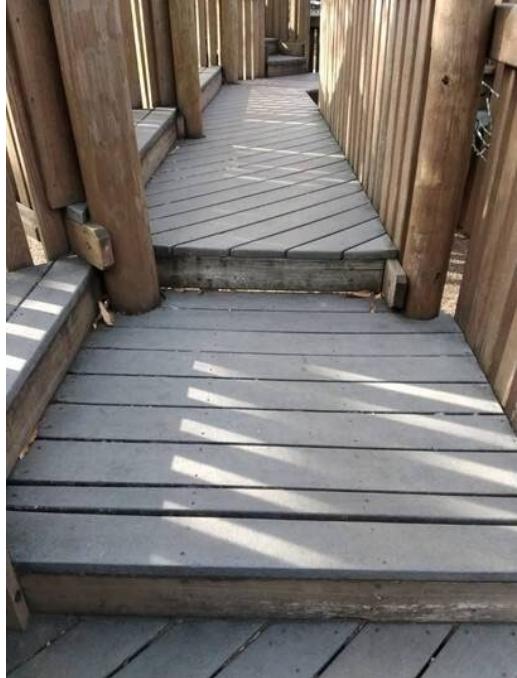
Decking picture #1

Grade C - The component has normal wear and tear.

The decking is in good condition. Some areas have sagged due to framing.

Repair / Replace damaged boards with similar materials.

Repair or replace areas with sagging decks and failed framing.

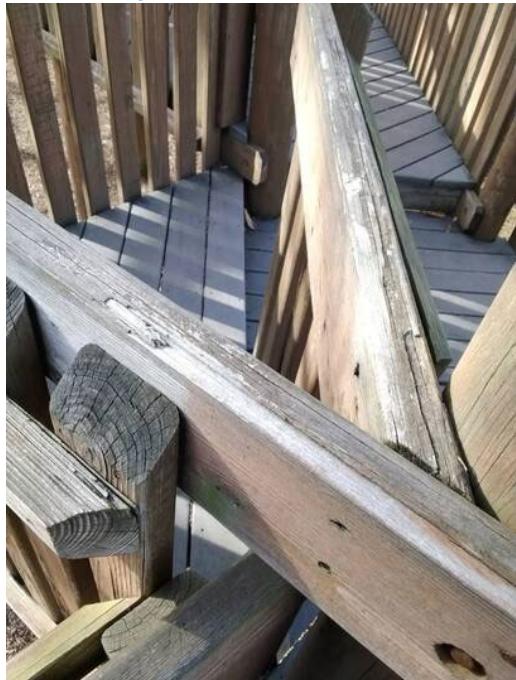
### **Handrail picture #1**

Grade C - The component has normal wear and tear.

Handrails are sound, but are weathered and worn. Some splintering and some loose fasteners in tot lot.

Sand and seal., Repair / Replace damaged handrail with similar materials.

Replace handrails with new materials.

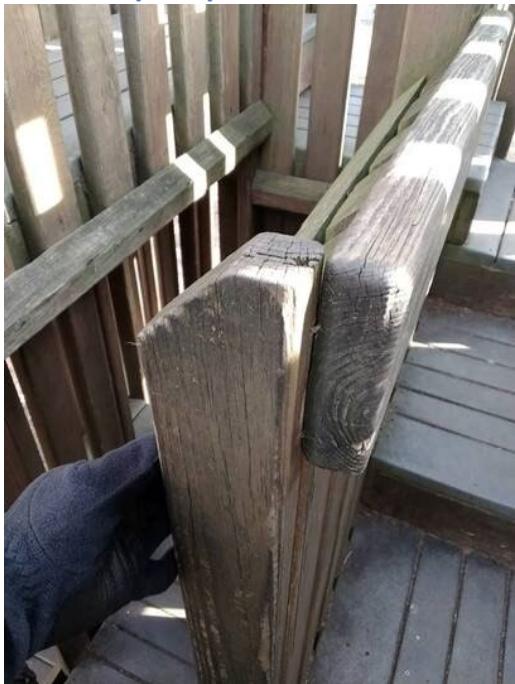
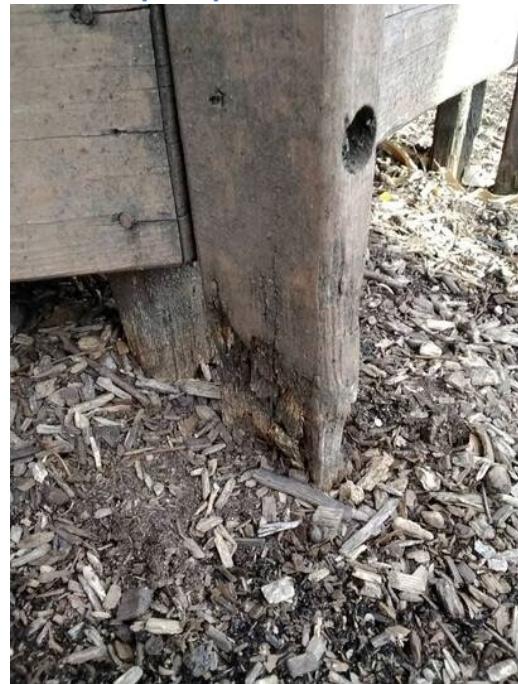
Grade D - The component shows signs of excessive wear and tear.

Some loose fasteners. Ground contact posts show significant decay.

Repair / Replace damaged handrail post with similar materials.

Replace with new materials.

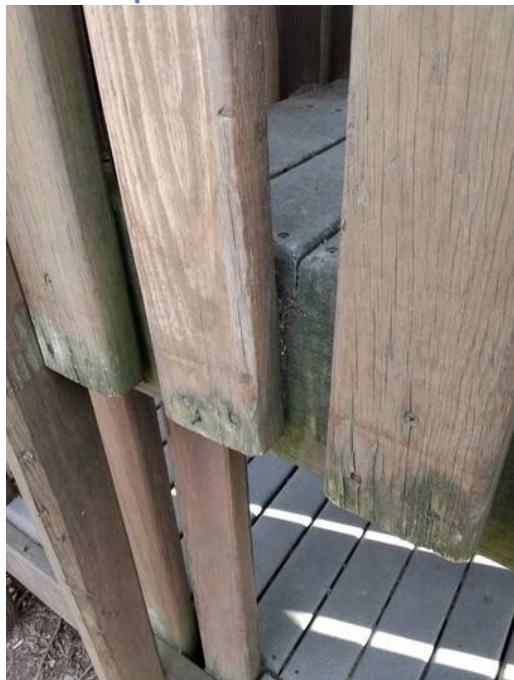
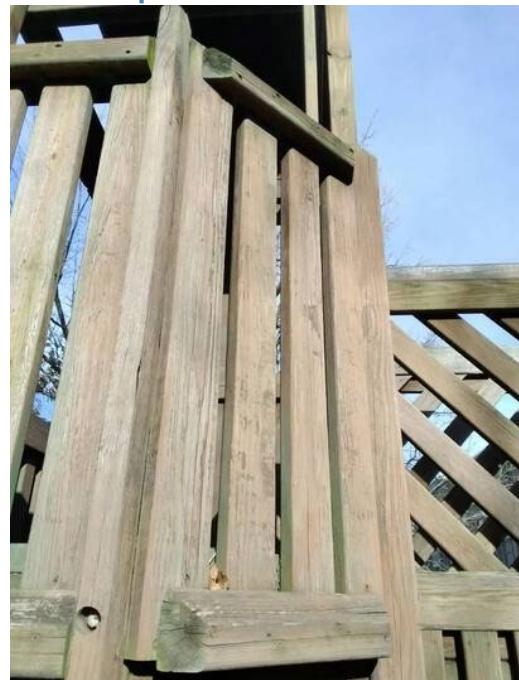
Grade C - The component has normal wear and tear.

Some missing trim cap. Sun exposed surfaces are weathered and splintering.

Sand and seal., Repair / Replace damaged balusters with similar materials., Repair / Replace damaged trim cap with similar materials.

Replace with new materials for better visibility.

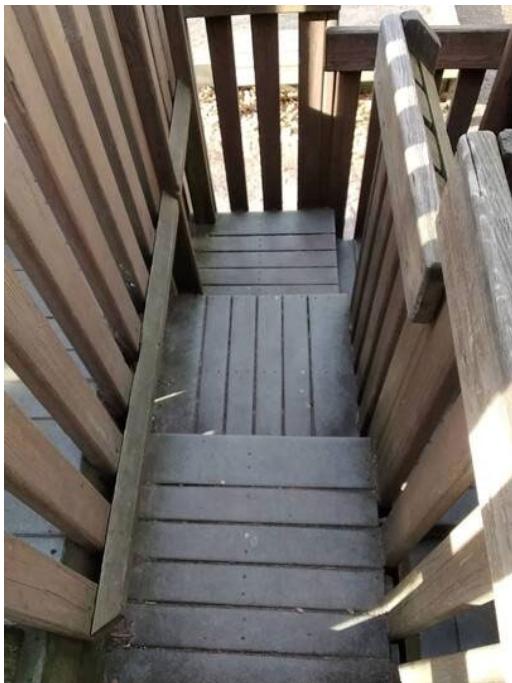
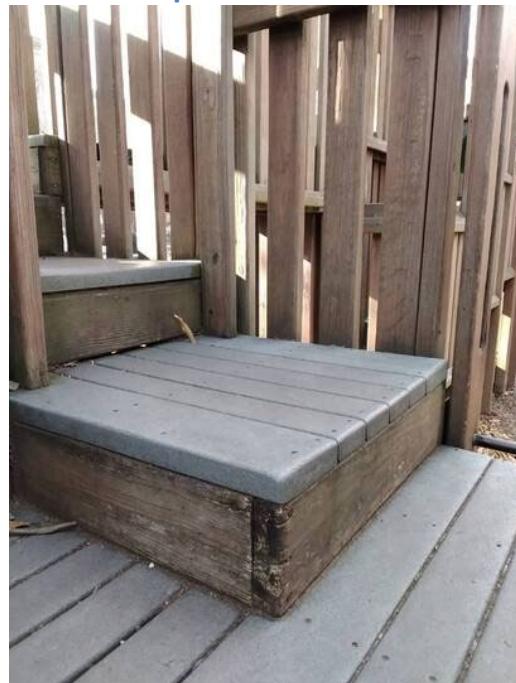
Grade C - The component has normal wear and tear.

Some loose fasteners. Tight and narrow corridors with limited access for adults.

Repair / Replace damaged framing with similar materials.

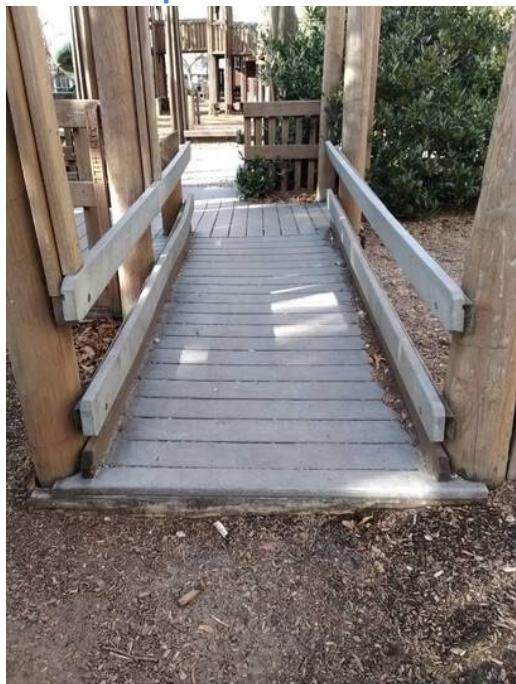
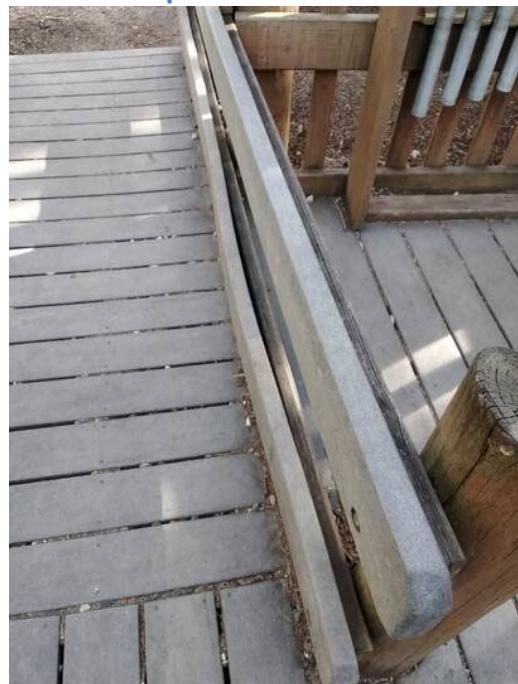
Grade C - The component has normal wear and tear.

Ramps are solid. Rails are separating. One pulled loose from post.

Replace rails with new ADA rails.

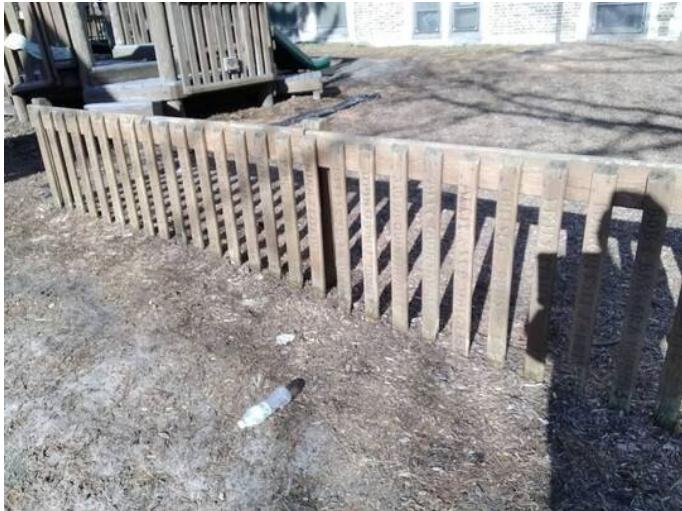
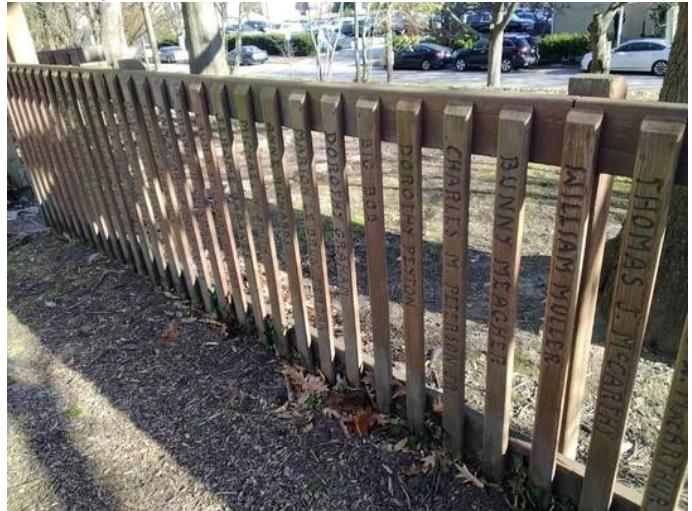
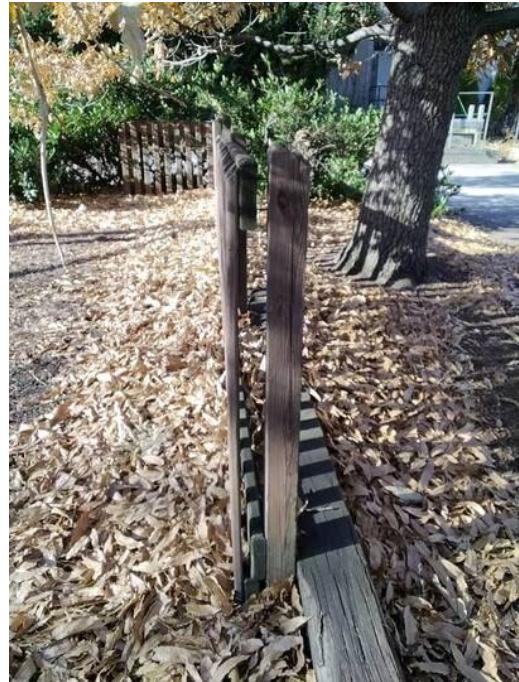
Grade C - The component has normal wear and tear.

Several missing pickets. Bottom rails show visible decay. Loose fasteners.

Replace missing / poor condition pickets., Repair / replace damage with similar materials.

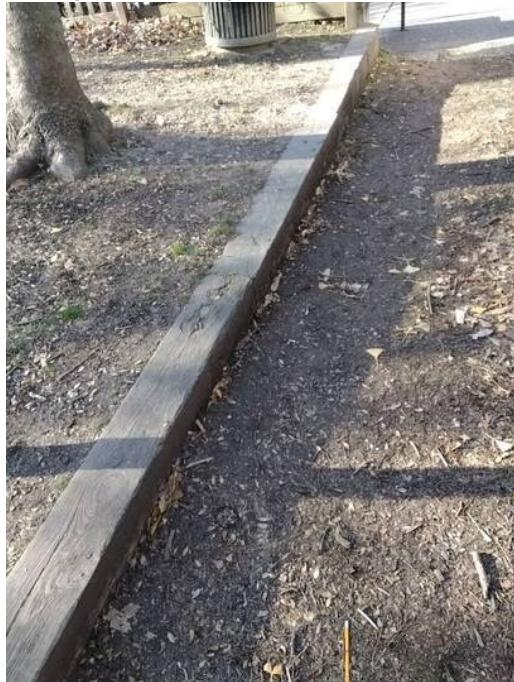
**Low perimeter picture #1**

Grade C - The component has normal wear and tear.

Posts are misaligned

Repair / Replace damaged perimeter with similar materials., Re-pin loose timbers.

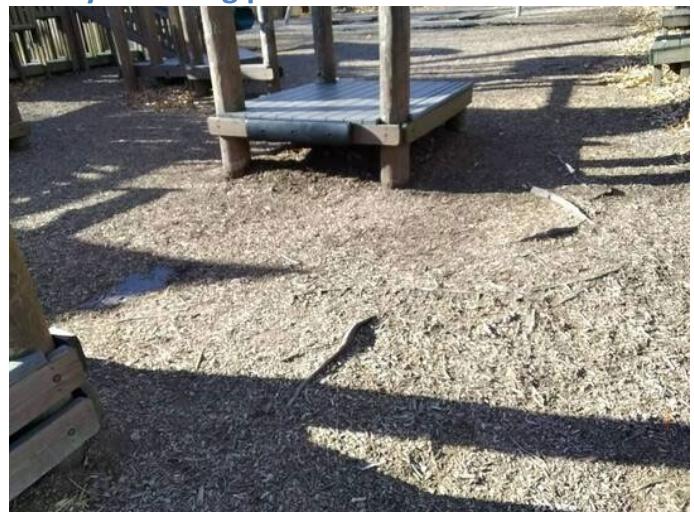
#### Safety surfacing picture #2

Grade F - The component is inoperative.

More than 10" Deficient throughout

Most surfacing has deteriorated. Exposed base layer. Roots are prevalent around the playground.

Add additional engineered wood fiber to a total depth of 12" throughout.

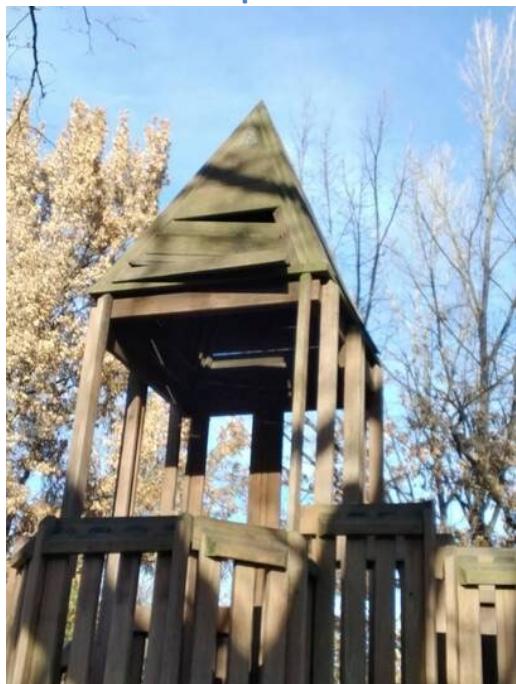
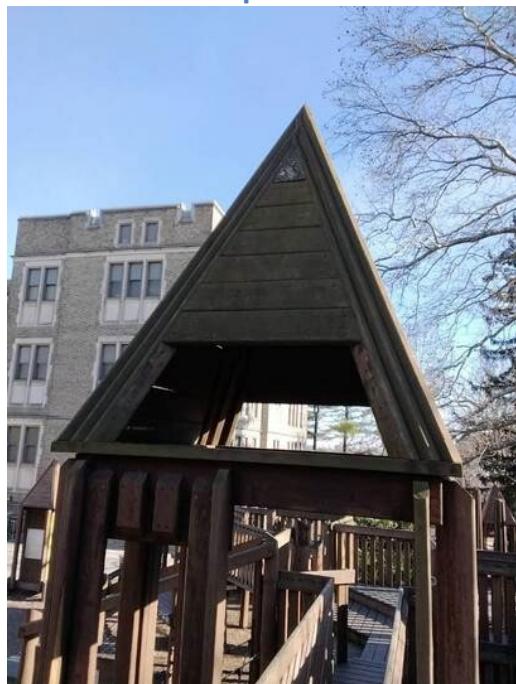
Grade D - The component shows signs of excessive wear and tear.

Missing boards and loose fasteners

Repair / Replace damage with similar materials., Replace sheathing with similar materials., Properly fasten existing sheathing., Repaint or Stain

Replace sheathing with new materials.

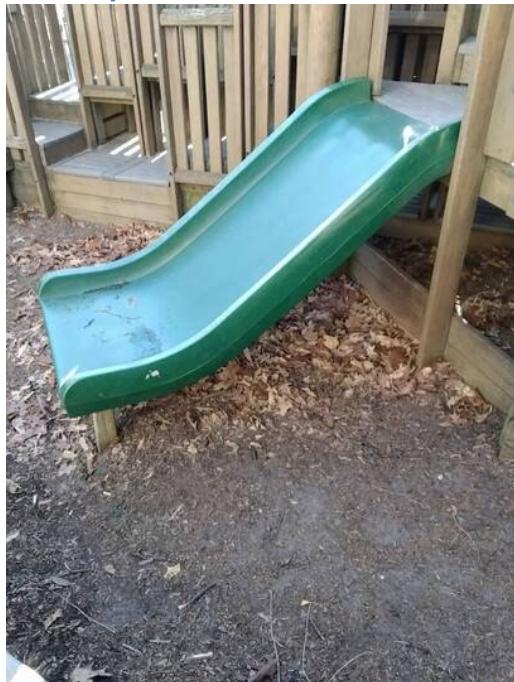
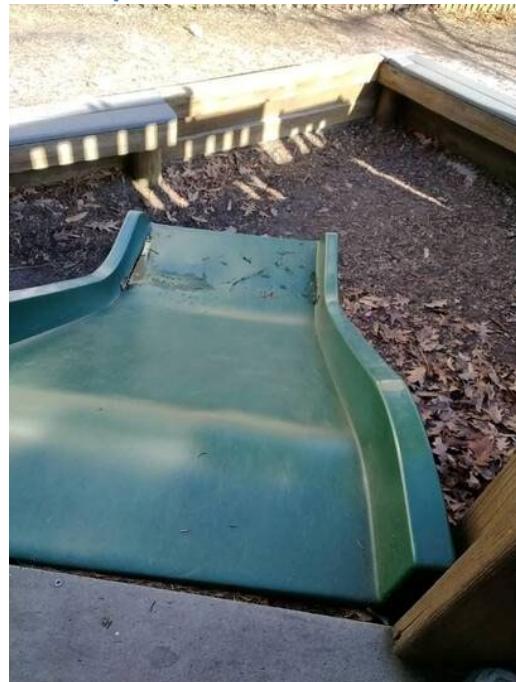
Grade C - The component has normal wear and tear.

Slide was possibly replaced

Replace with new slide.

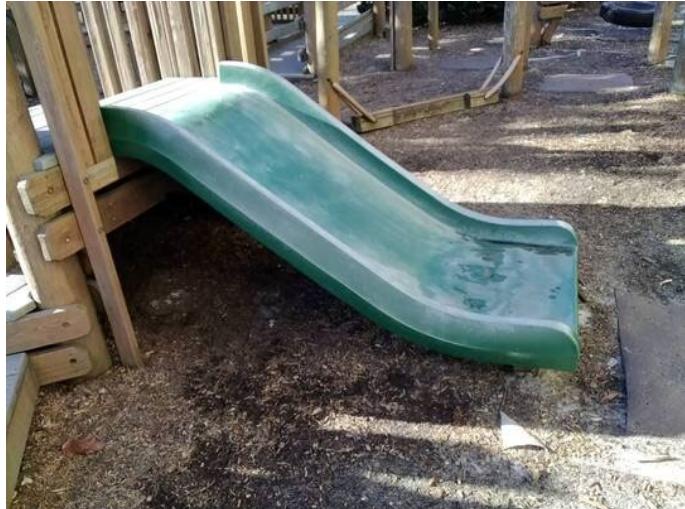
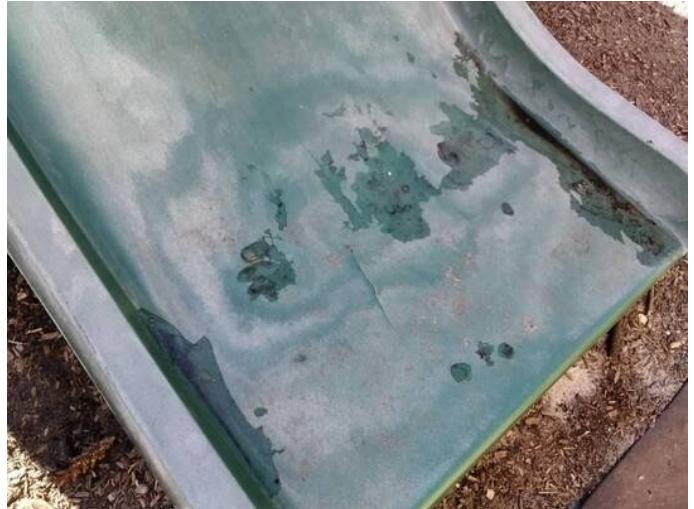
Grade D - The component shows signs of excessive wear and tear.

Slide is cracked at bottom mount points

Replace with new slide.

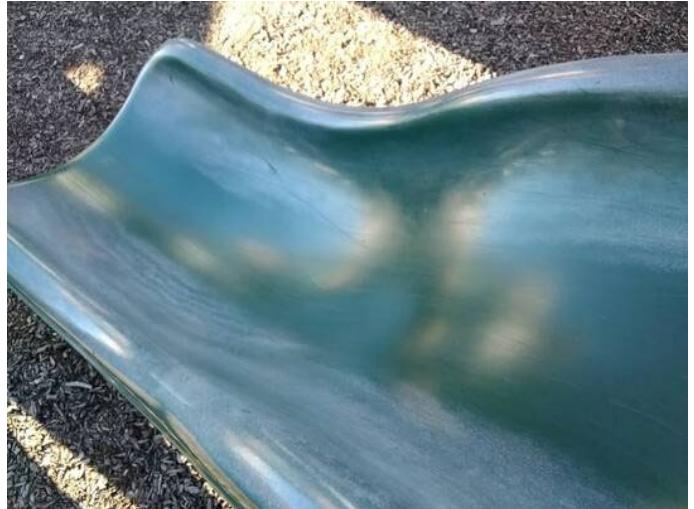
#### Slide 3 picture #2

Solid supportive good condition.

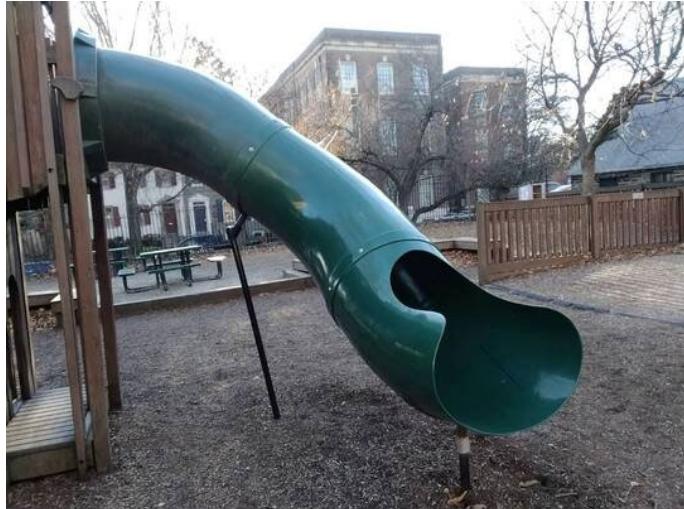
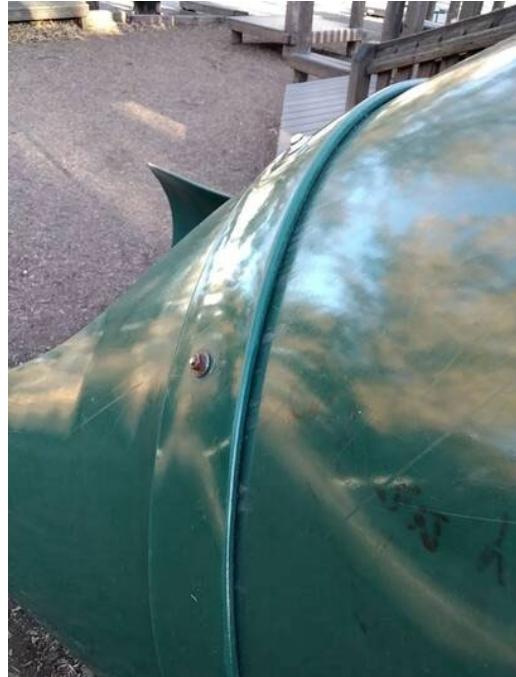
Grade C - The component has normal wear and tear.

Some bolts were replaced with common hardware

Replace missing bolts., Repair damage with similar materials.

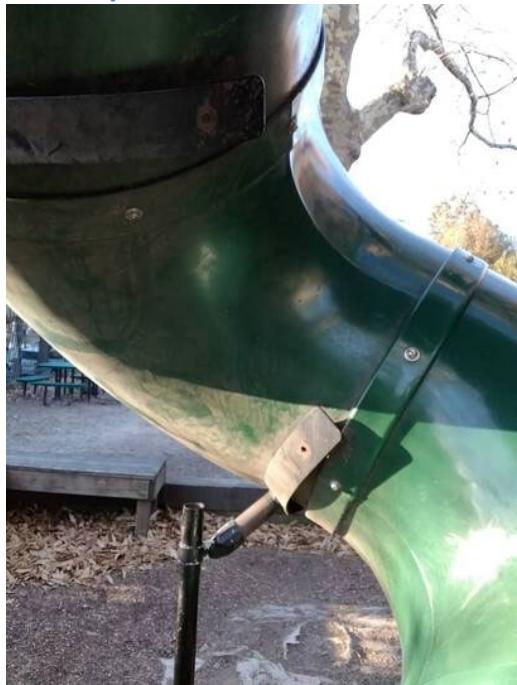
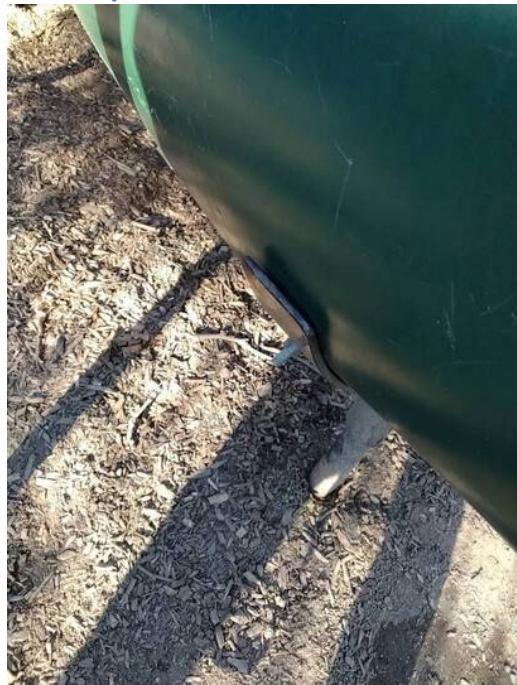
Grade D - The component shows signs of excessive wear and tear.

Replace missing bolts., Repair damage with similar materials.

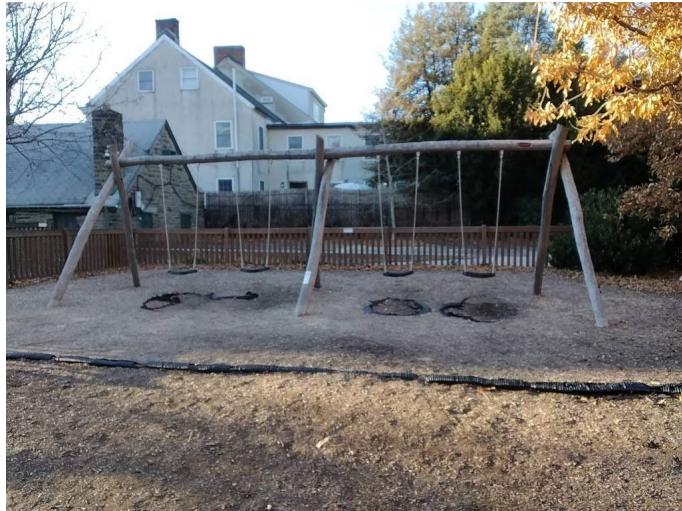
#### Swings 5-12 picture #1

Structures have been removed and replaced by other manufacturers.

Replace with new manufactured swings.

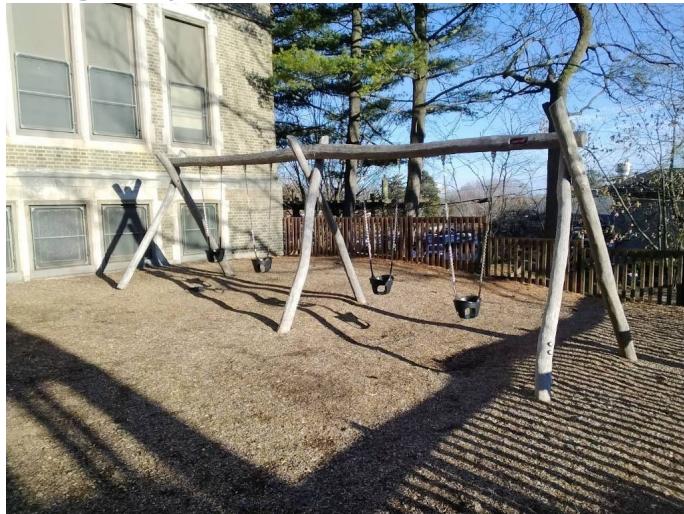
### Swings 2-5 picture #1

Structures have been removed and replaced by other manufacturers.

Replace with new manufactured swings.

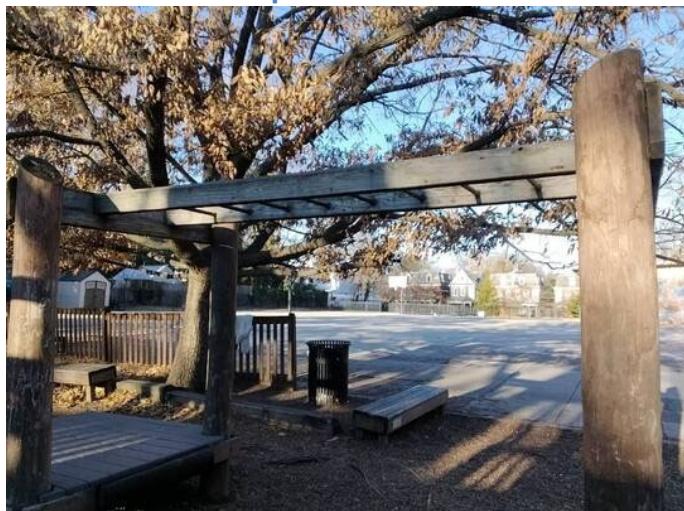
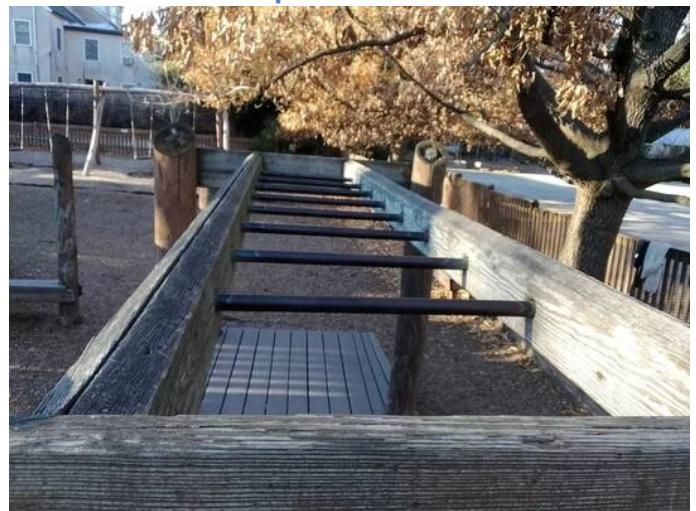
Grade C - The component has normal wear and tear.

Replace with new manufactured equipment.

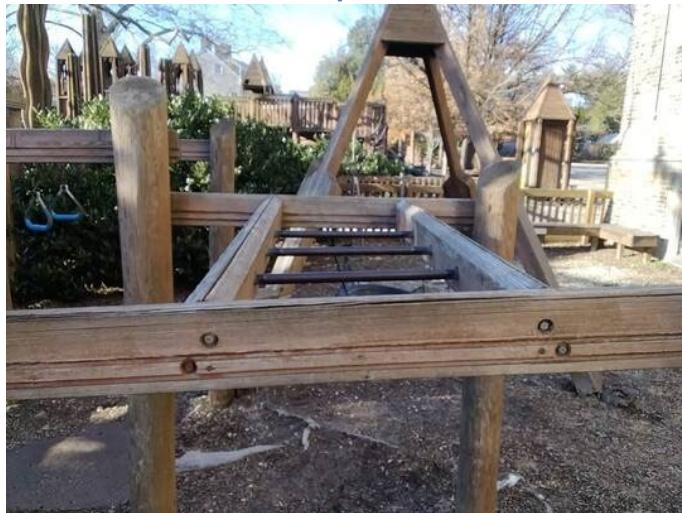
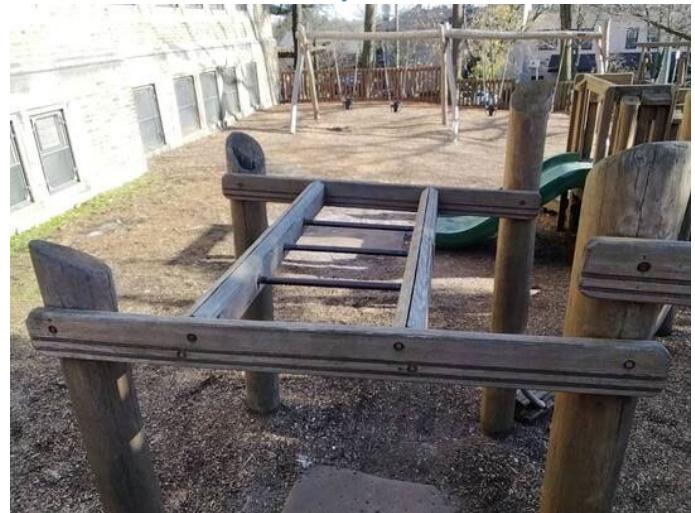
Grade D - The component shows signs of excessive wear and tear.

Posts has significant decay. Beams are splintering

Repair / Replace damage with similar materials., Make any necessary repairs.

Replace with new equipment

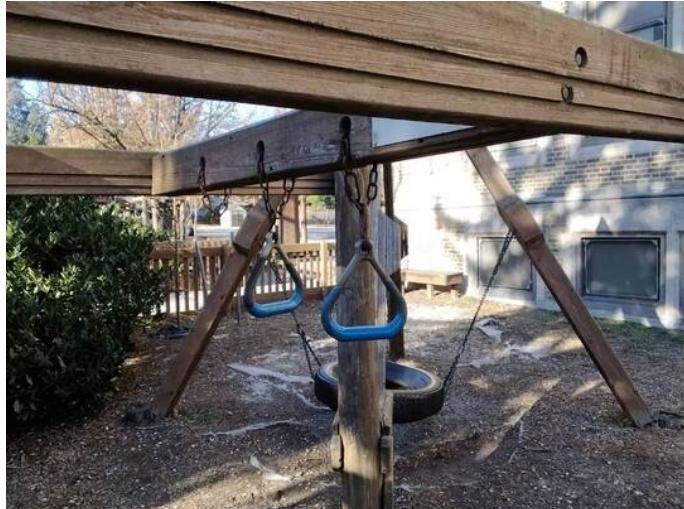
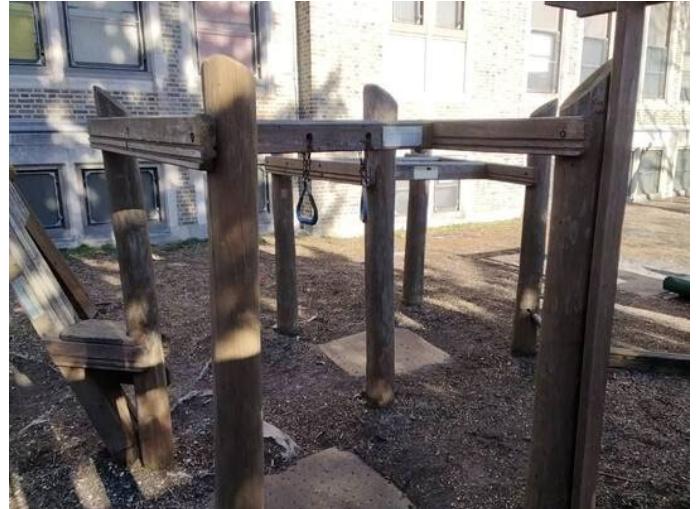
Grade D - The component shows signs of excessive wear and tear.

Missing rings

Repair / Replace damage with similar materials.

Replace with new equipment

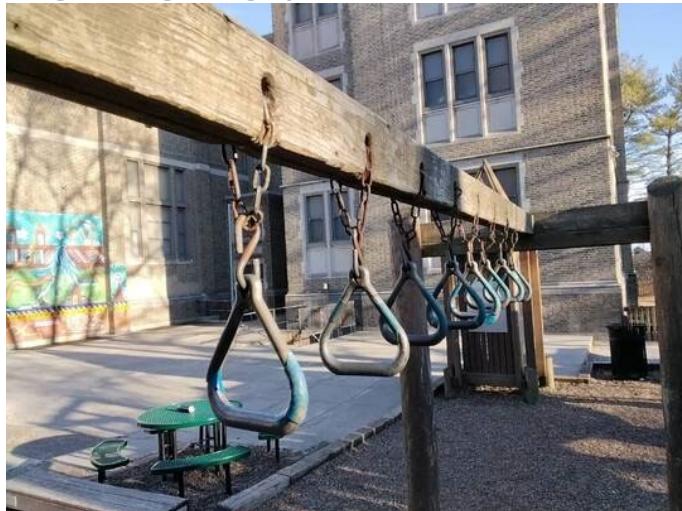
### Rings / Ring Bridge picture #1

Grade D - The component shows signs of excessive wear and tear.

Missing rung, hardware is worn. Beam is worn.

Repair / Replace damage with similar materials., Replace hardware., Make any necessary repairs.

Replace with new manufactured equipment.

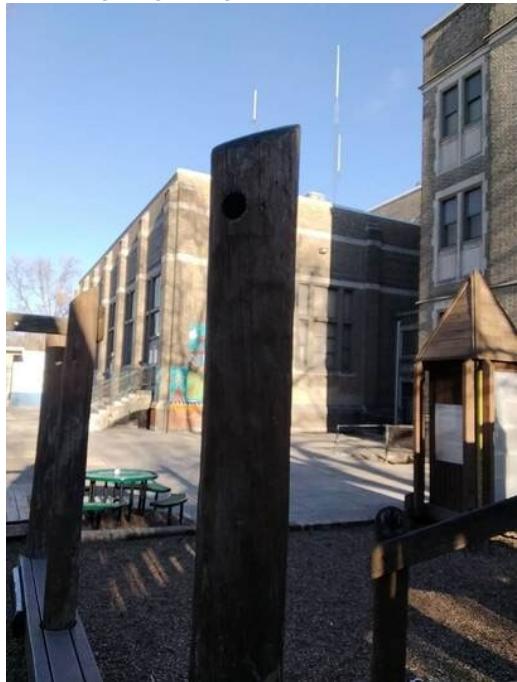
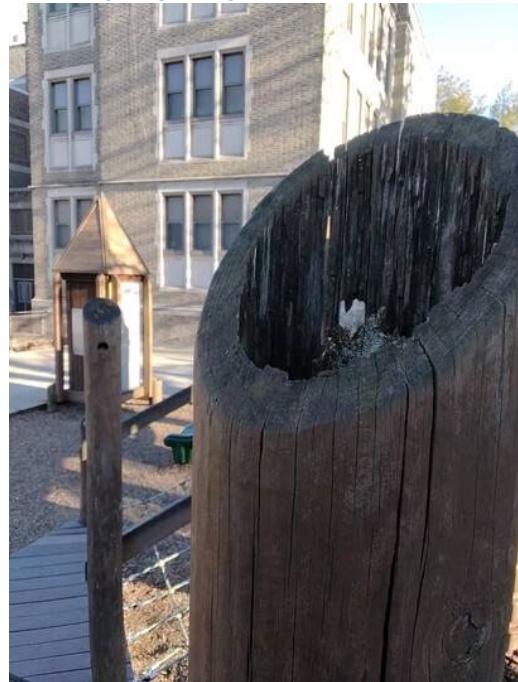
Pipe has been removed. Post is decayed.

Repair / Replace damage with similar materials., Make any necessary repairs.

Replace with new equipment.

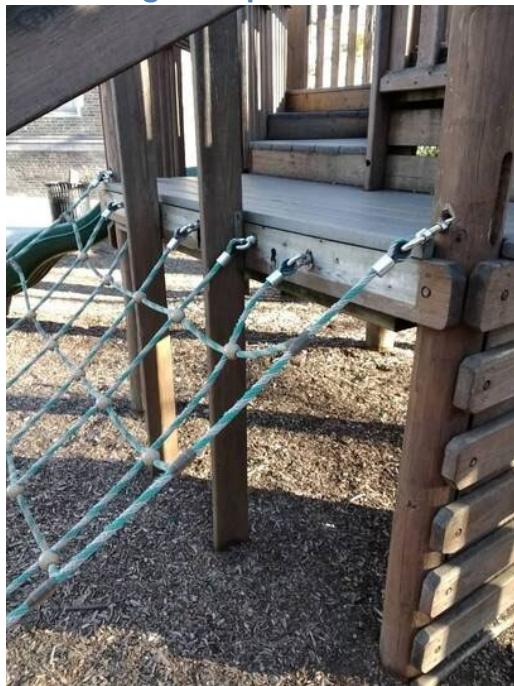
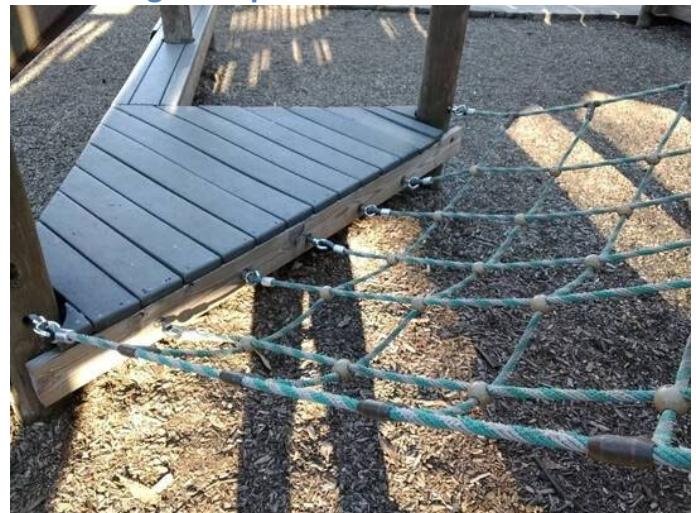
Grade C - The component has normal wear and tear.

Chain & hose have been replaced. Connections need to be tightened

Readjust net and tighten connections.

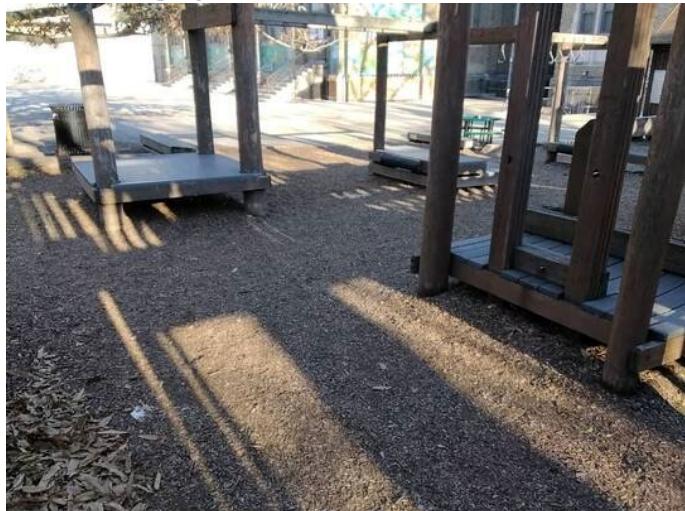
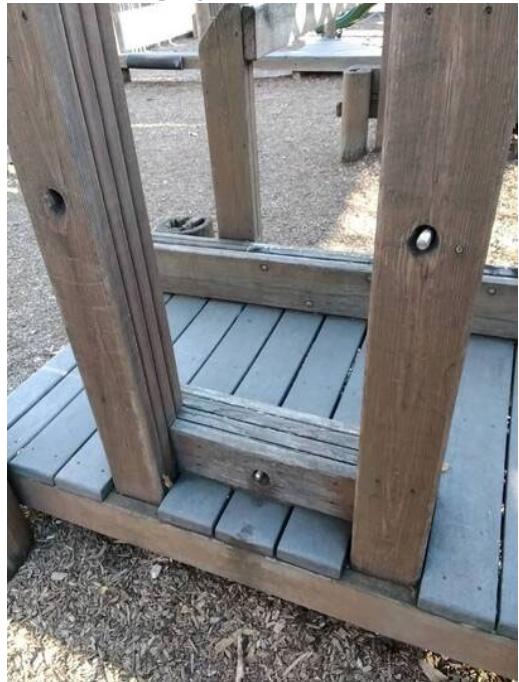
Missing equipment. 129" & 127"

Replace with new equipment

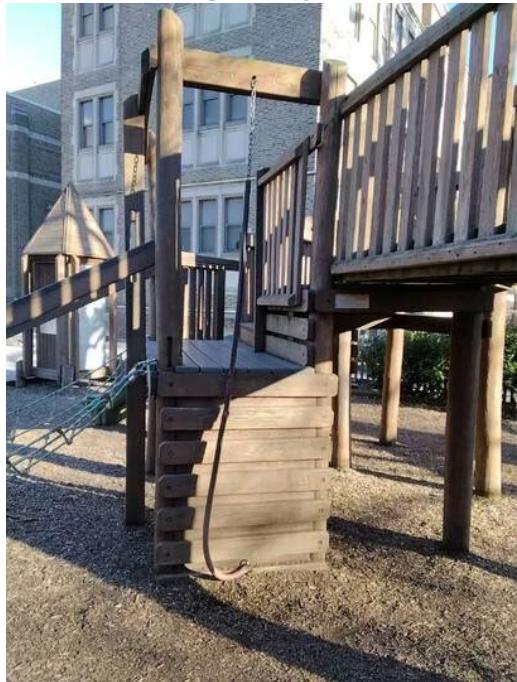
#### Chain Climbing Wall picture #1

Grade D - The component shows signs of excessive wear and tear.

Hose is worn and chain pull is too long.

Replace damaged hose., Repair / Replace damage with similar materials.

Replace with new cable version.

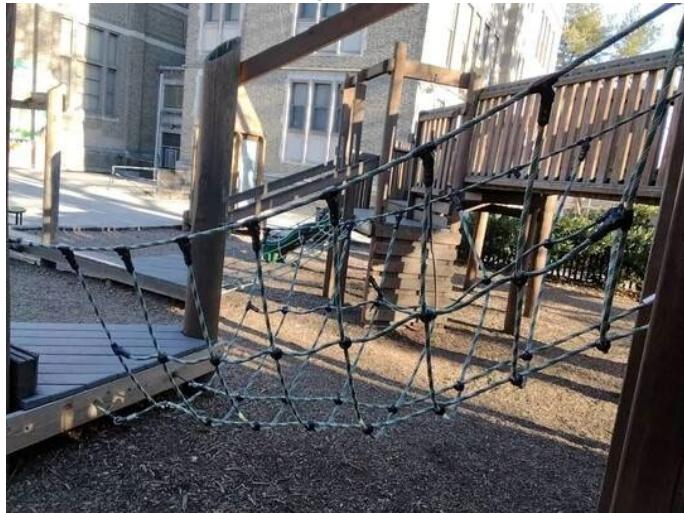
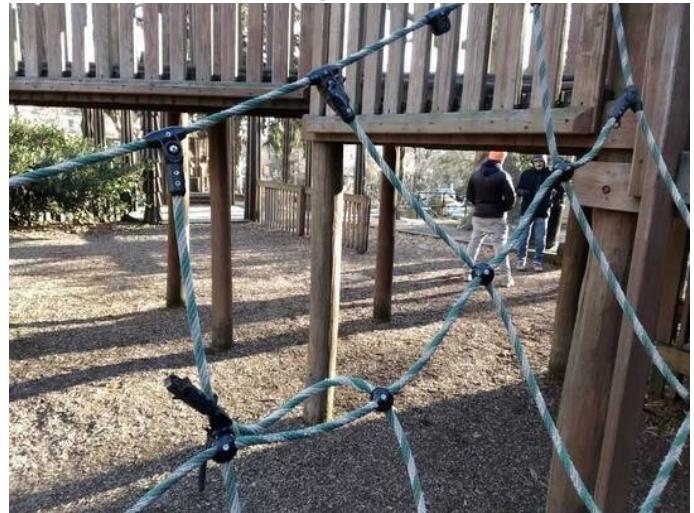
Grade D - The component shows signs of excessive wear and tear.

Cable is worn. Section is broken. Attachment bolts are loose. Upper 116" 111"

Remove & replace with other play element.

Replace with new cable version.

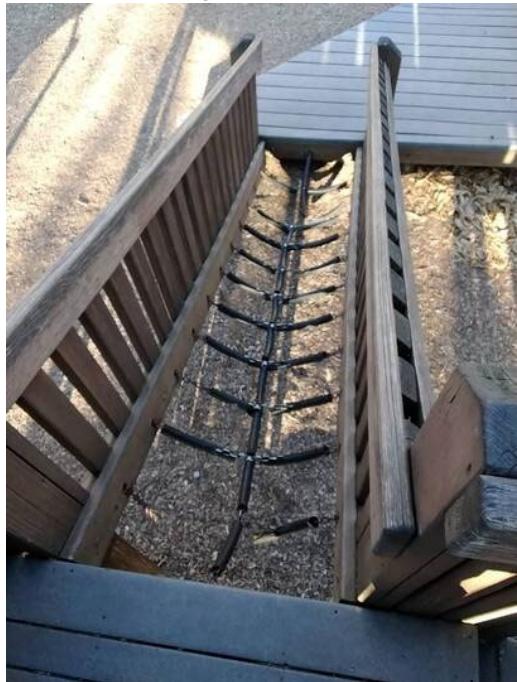
#### Chain Ladder picture #1

Chain and hardware is severely worn. 25" x 127"

Remove & replace with other play element.

Replace with new cable version

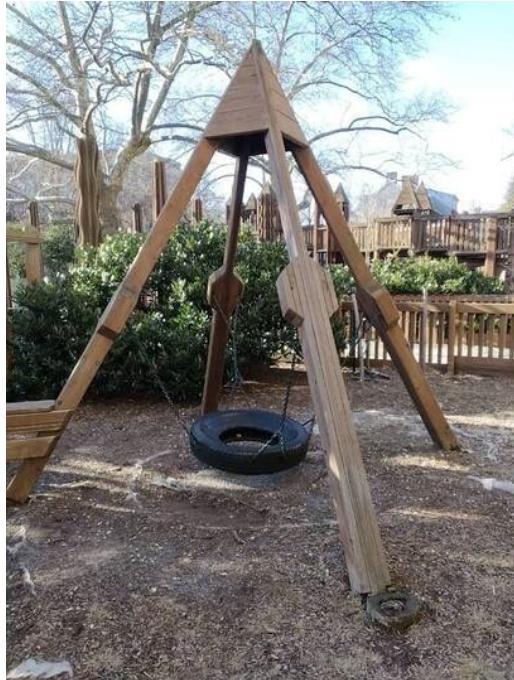
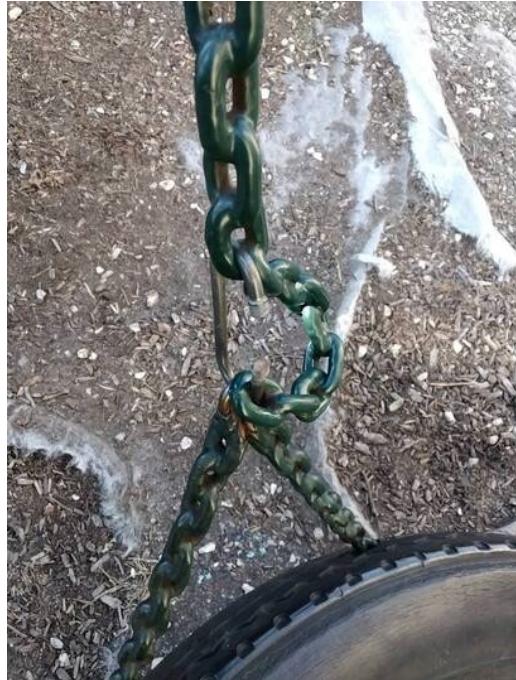
Grade D - The component shows signs of excessive wear and tear.

Hardware is significantly worn. Structures are sound but weathered.

Replace damaged / worn hardware., Repair / Replace damage with similar materials.

Replace with new equipment

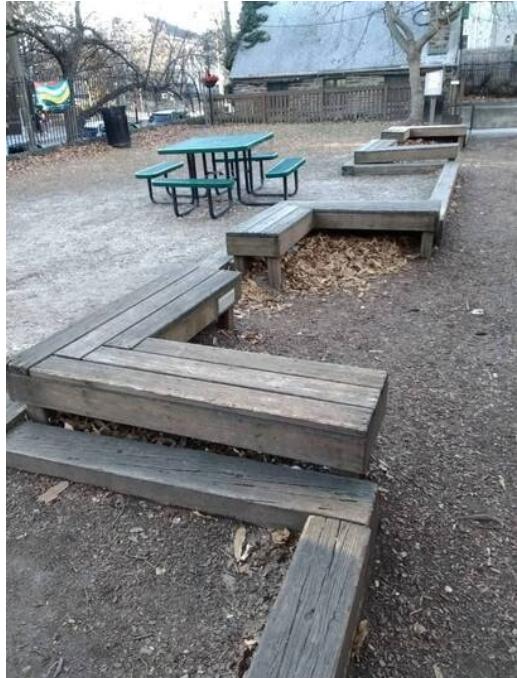
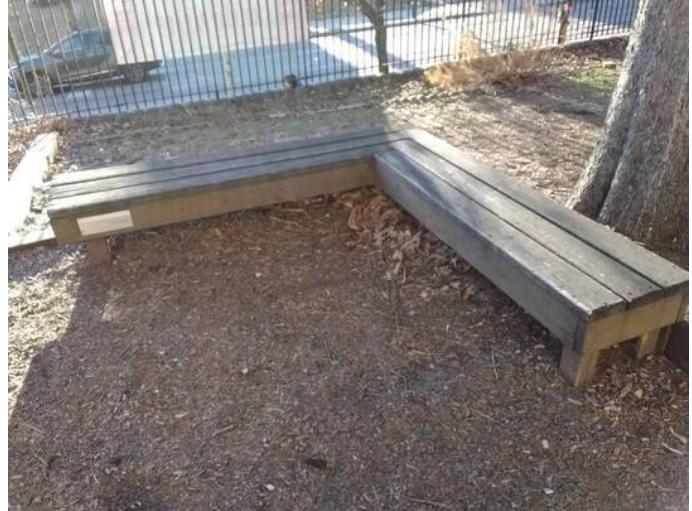
Grade D - The component shows signs of excessive wear and tear.

Remove and replace seating surfaces with similar materials.

Replace seating with new materials.

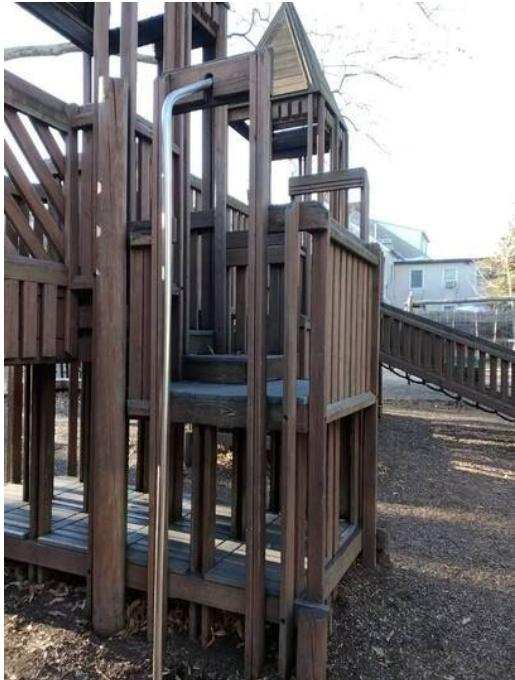
#### Fire pole picture #1

Grade C - The component has normal wear and tear.

Replace with new.

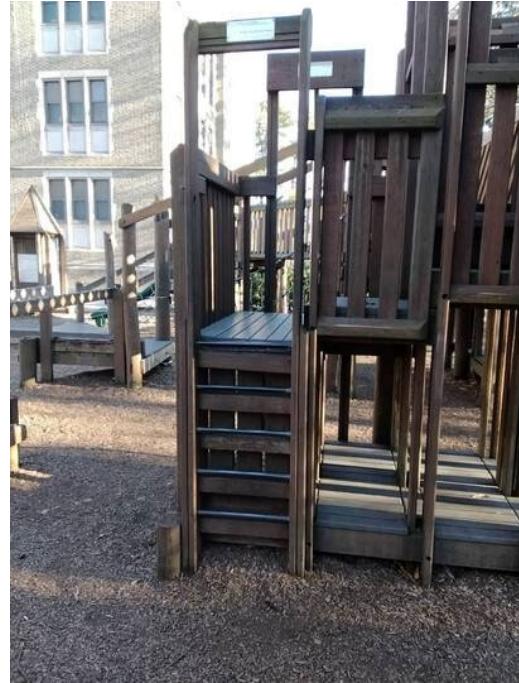
#### Vertical Ladder picture #2

Grade C - The component has normal wear and tear.

Top backing is loose and uneven

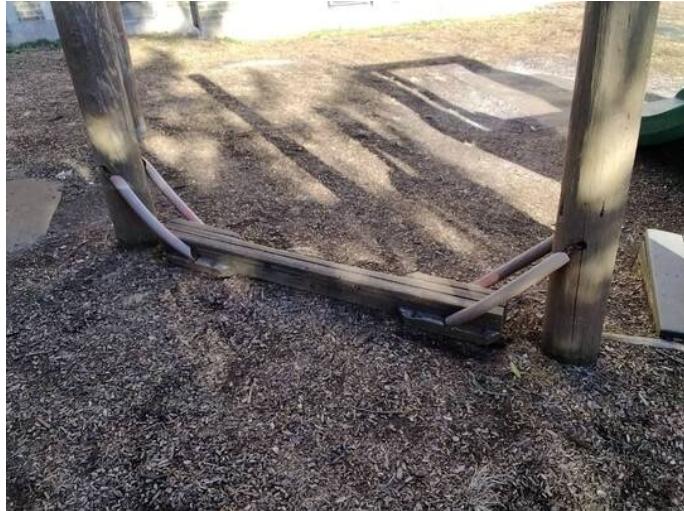
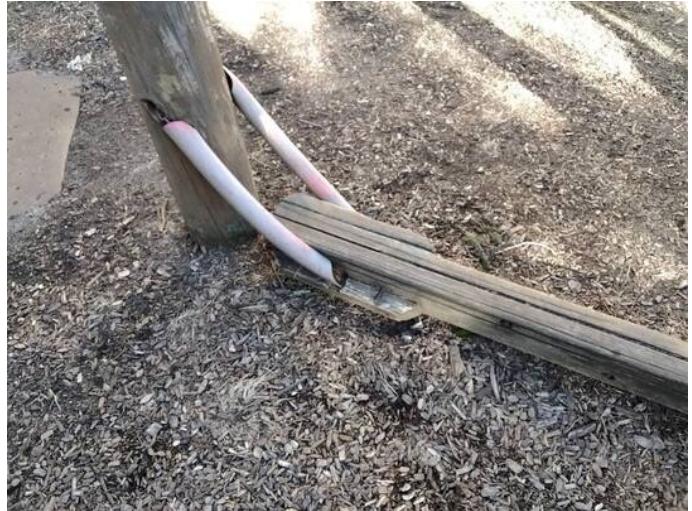
Grade D - The component shows signs of excessive wear and tear.

Broken and uneven

Repair / Replace damage with similar materials.

Replace with new play equipment.

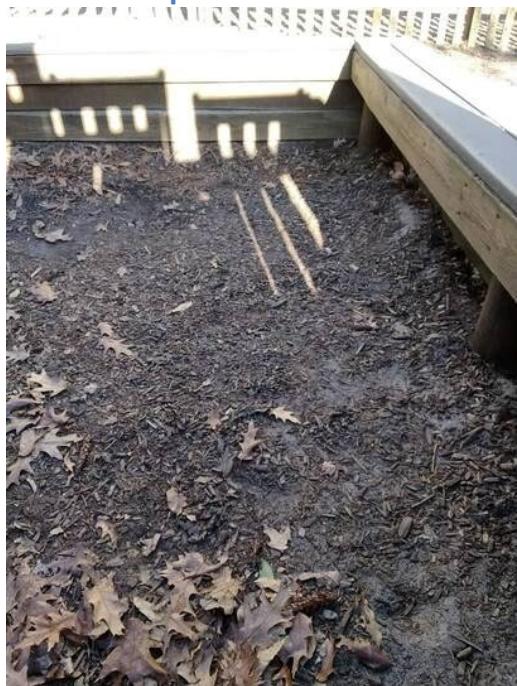
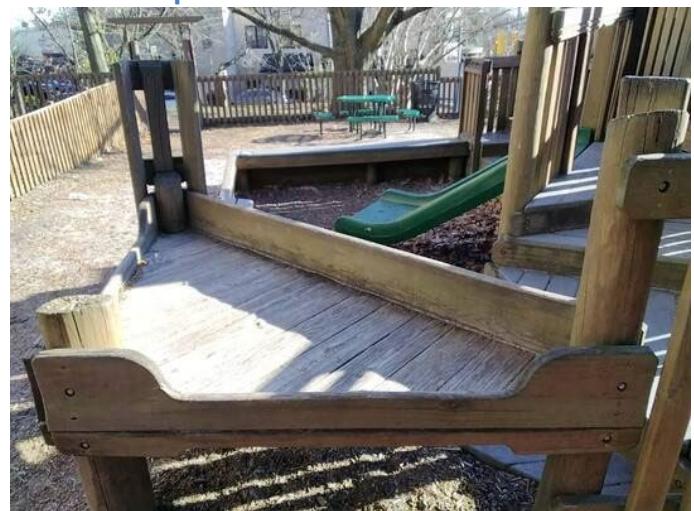
Sand is missing, creating a deep, low area

Reimagine area for major renovation.

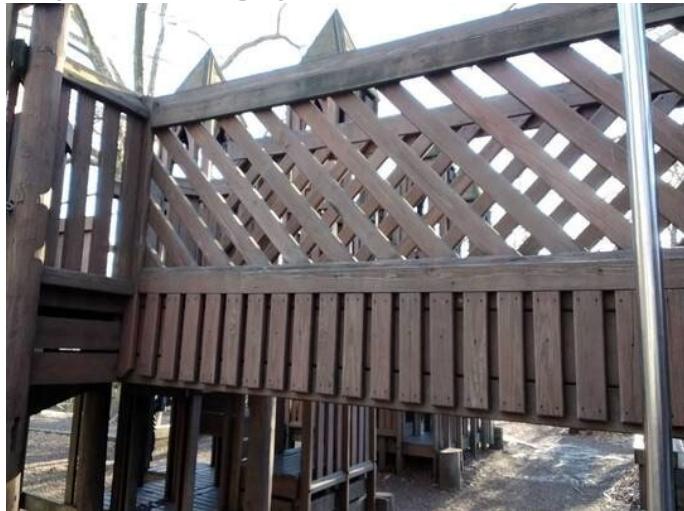
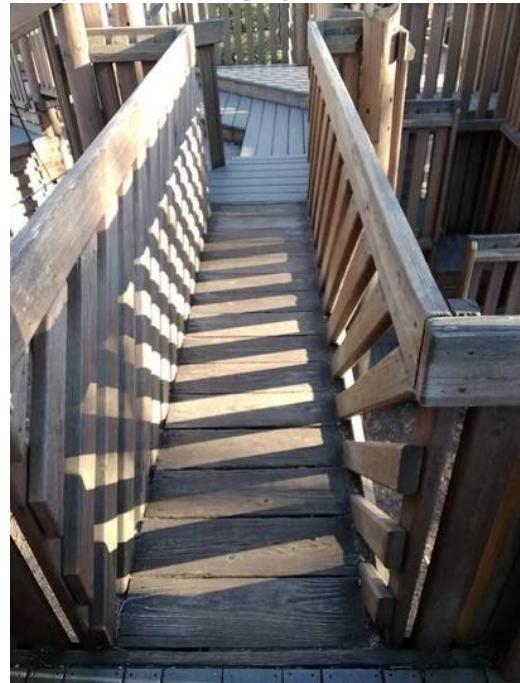
Bridge was replaced with fixed bridge

Replace with new equipment.
