## Assessment Report for: JS Jenks Academy

<b>Inspection Date:</b> Friday, Dec 12, 2025	<b>Playground Name:</b> Philadelphia PA #3196	<b>Report Date:</b> 01/8/26
<b>Inspector:</b> Bill Meyers	<b>Date playground was built:</b> 1997	<b>Report submitted by:</b> Marc Leathers

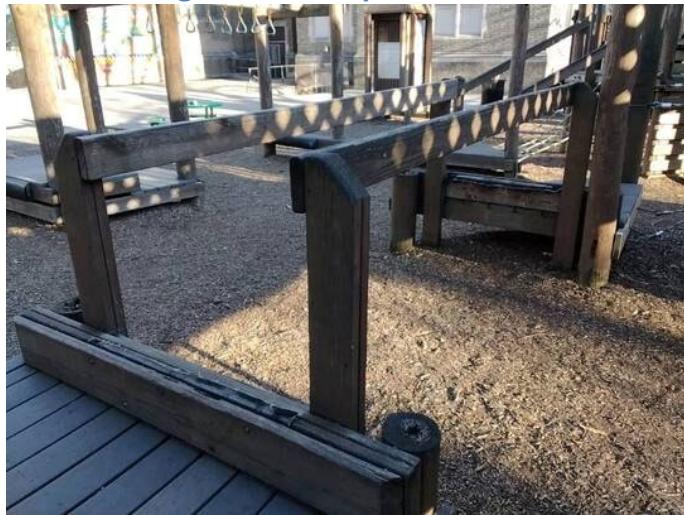
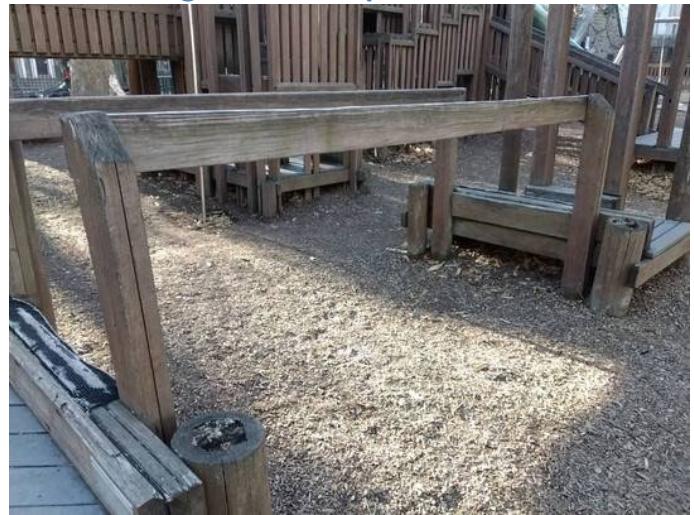
Rubber bridge is missing

Repair / Replace damage with similar materials., Replace rubber conveyer belt.

Replace with new equipment

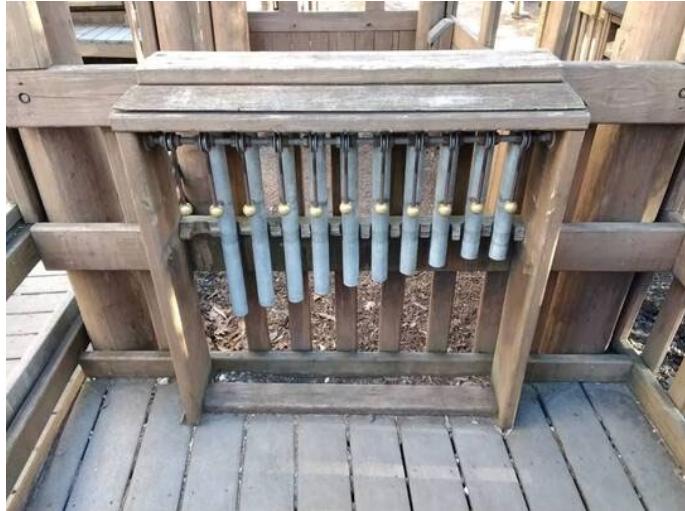
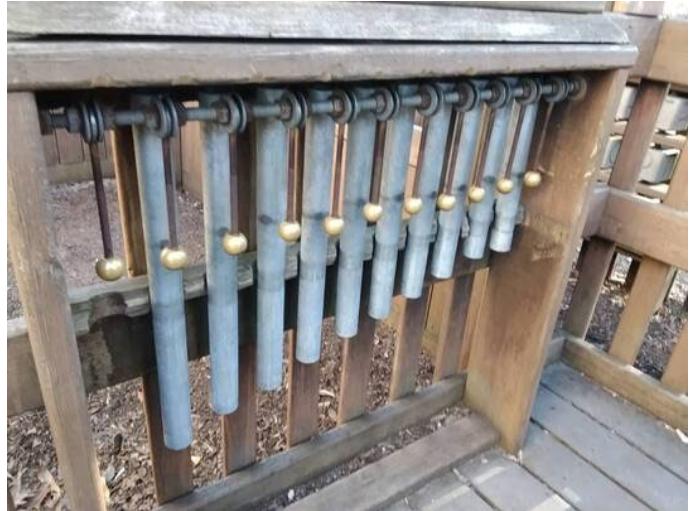
Grade D - The component shows signs of excessive wear and tear.

Broken equipment and missing pieces

Remove & replace with new play element.

Replace with new equipment
