## Assessment Report for: JS Jenks Academy

<b>Inspection Date:</b> Friday, Dec 12, 2025	<b>Playground Name:</b> Philadelphia PA #3196	<b>Report Date:</b> 01/8/26
<b>Inspector:</b> Bill Meyers	<b>Date playground was built:</b> 1997	<b>Report submitted by:</b> Marc Leathers

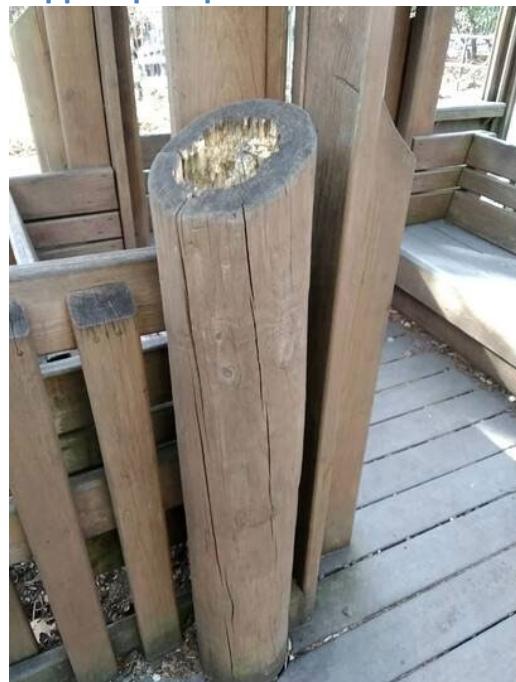
#### Support post picture #2

Grade C - The component has normal wear and tear.

In ground posts show normal wear with minor decay. Many posts have significant dry rot along tops.

Sand and seal weathered posts., Trim damaged top back to dense wood and seal., Repair / Replace damaged poles with similar materials.

In addition to minor recommendations, replace posts with new materials in areas to be reimagined during major renovation.

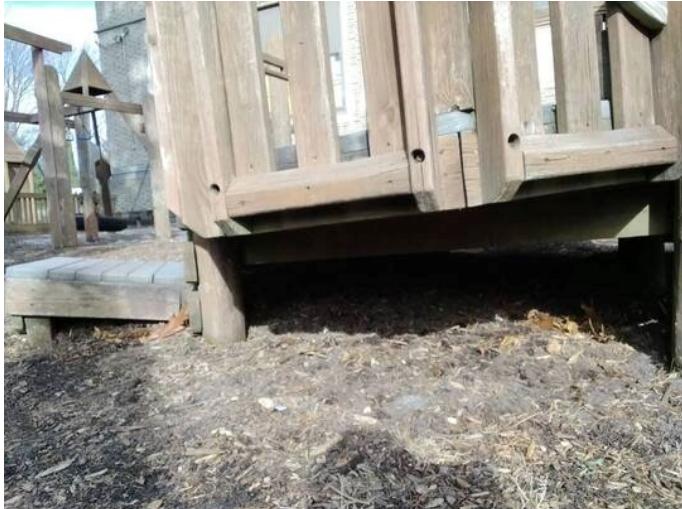
**Framing picture #1**

Grade C - The component has normal wear and tear.

Repair / Replace damaged framing with similar materials.

Consider replacing tot area structures.

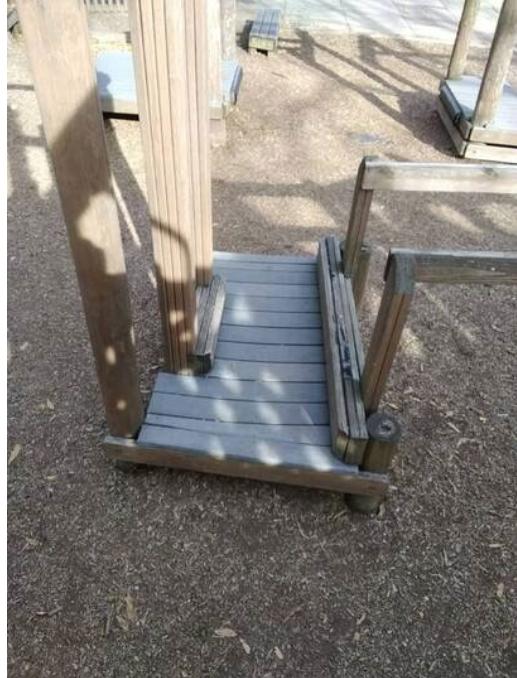
Decking picture #2

Grade C - The component has normal wear and tear.

The decking is in good condition. Some areas have sagged due to framing.

Repair / Replace damaged boards with similar materials.

Repair or replace areas with sagging decks and failed framing.

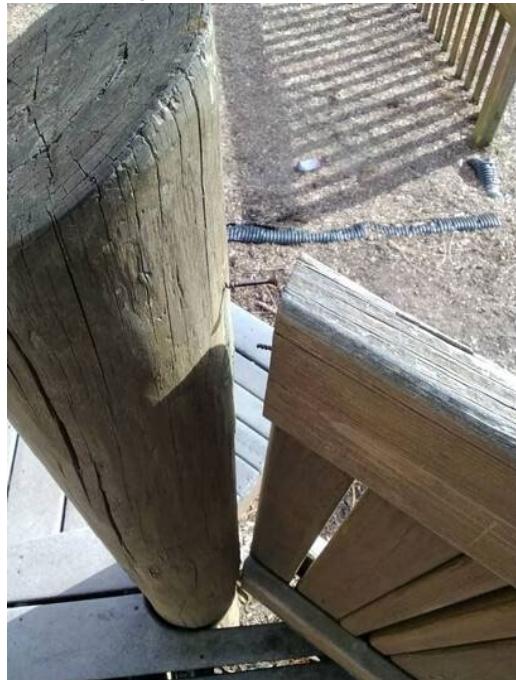
### **Handrail picture #2**

Grade C - The component has normal wear and tear.

Handrails are sound, but are weathered and worn. Some splintering and some loose fasteners in tot lot.

Sand and seal., Repair / Replace damaged handrail with similar materials.

Replace handrails with new materials.

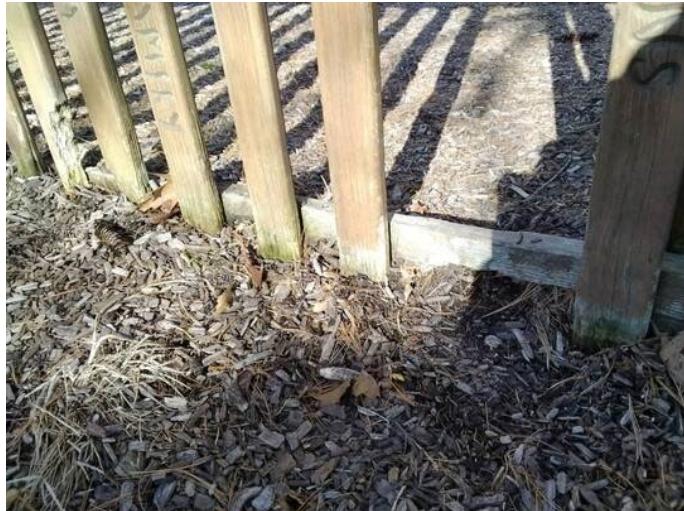
Fence picture #3

Grade C - The component has normal wear and tear.

Several missing pickets. Bottom rails show visible decay. Loose fasteners.

Replace missing / poor condition pickets., Repair / replace damage with similar materials.

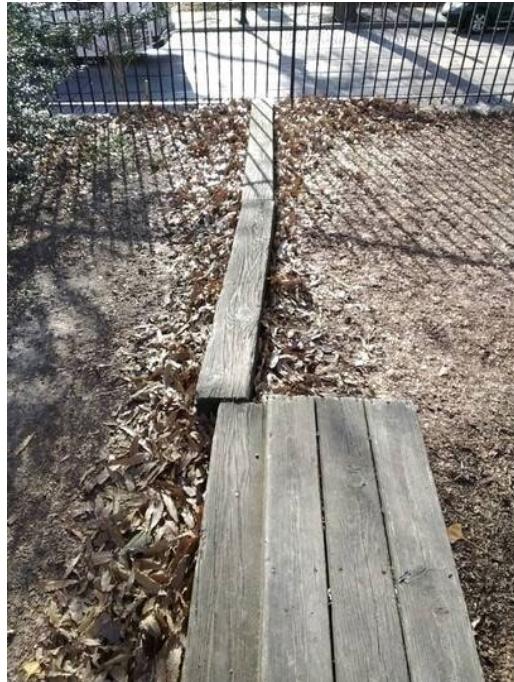
**Low perimeter picture #2**

Grade C - The component has normal wear and tear.

Repair / Replace damaged perimeter with similar materials., Re-pin loose timbers.

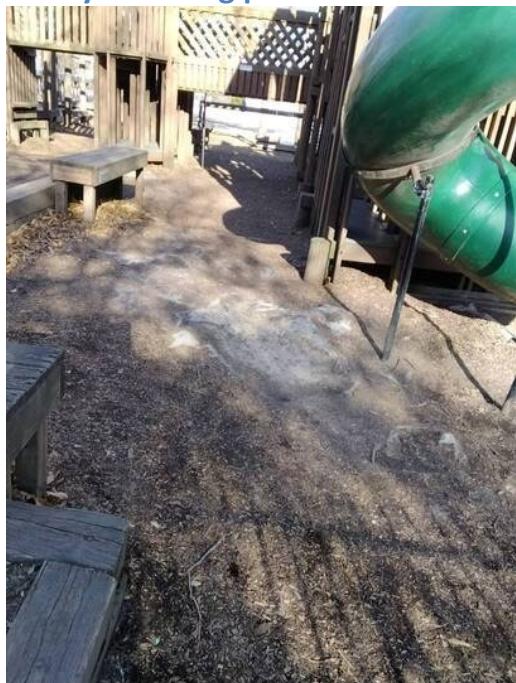
#### Safety surfacing picture #1

More than 10" Deficient throughout

Most surfacing has deteriorated. Exposed base layer. Roots are prevalent around the playground.

Add additional engineered wood fiber to a total depth of 12" throughout.

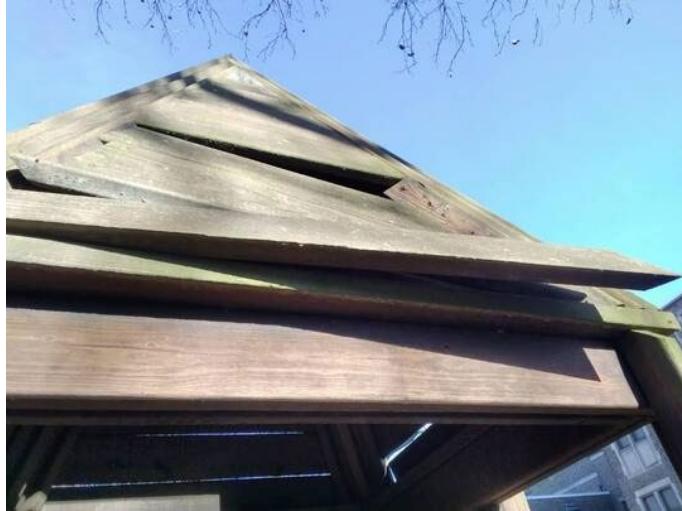
Roofs & Towers pictures #3

Grade D - The component shows signs of excessive wear and tear.

Missing boards and loose fasteners

Repair / Replace damage with similar materials., Replace sheathing with similar materials., Properly fasten existing sheathing., Repaint or Stain

Replace sheathing with new materials.
